Structural Inspection of Existing CSX Bridge at Kanawha River Charleston, WV

**January 5, 2004
Revised January 14, 2004**

**Ham Engineering, Inc.
Structural Engineers
411 1/2 D Street Suite 2
South Charleston, WV 25303
Phone: (304) 744-3017
Fax: (304) 744-3196
Email: jham@hamengineer.com**

Subject: Preliminary Structural Inspection of the Existing CSX Bridge, Charleston, WV

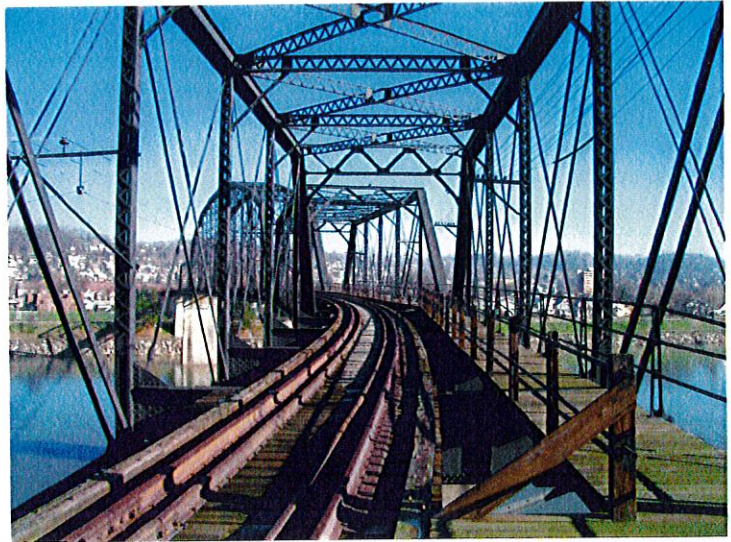
View thru South Truss showing track and walkway on the upstream side of the bridge. The existing wood deck and handrails will have to be replaced.

Remove the existing wood walkways located inside of the trusses and upriver of the railroad tracks. The deck can be replaced in kind or in specific sections as determined later.

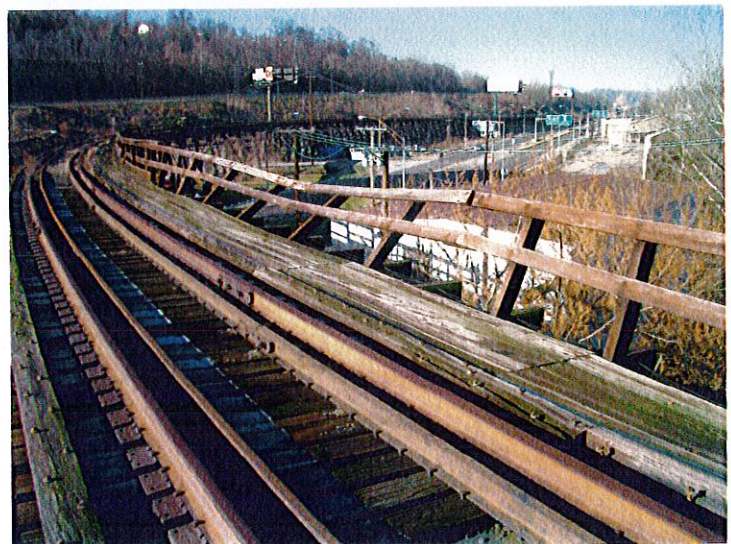
Both the north and south wood trestle and steel girder approach spans have a wood sidewalk and handrail cantilevered from the west side of the tracks. This sidewalk and handrail is in very poor condition and should be removed completely from the structure. At present, the existing sidewalk does not appear to be physically attached, just a wood stringer that extends parallel to the crossties and bears under the rails, preventing uplift of the sidewalk stringer.

Failing handrail and walkway at the South Approach spans. The existing walkway and handrails should be removed.

Remove the existing wood walkway and handrail system on both the north and south approaches due to their poor condition. This walkway and handrail will be replaced with a new walkway system.

Remove the existing wood sidewalk and handrail system from both the north and south approach spans. The existing walks will not be replaced. It is assumed that most of the demolition work will be done by crane from grade.

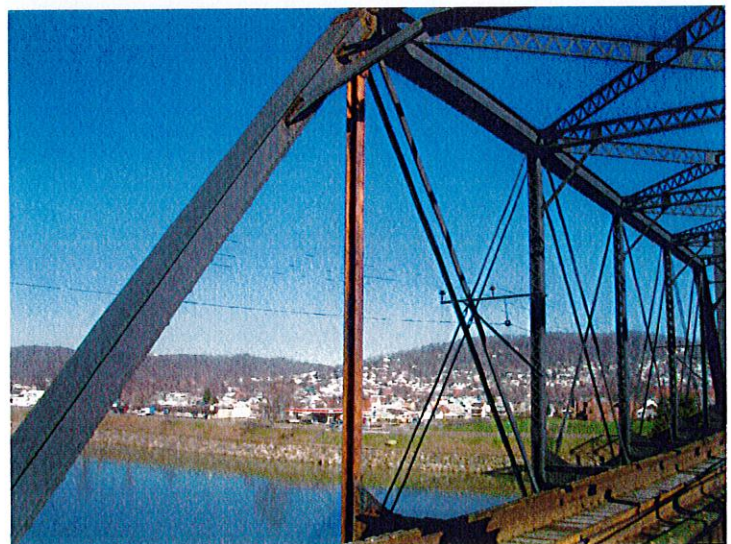
Replaced Vertical Member at south end of second truss, an indication of possible damage or corrosion repair. Note the reddish orange color of the paint.

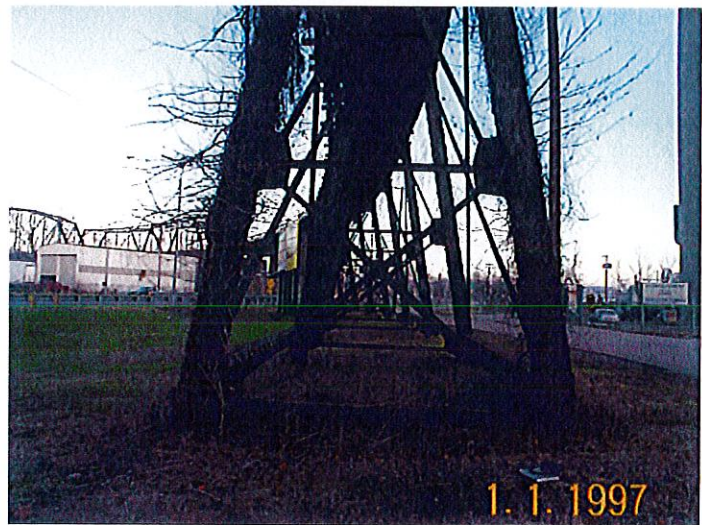
At the south approach, extensive vegetation and poor site drainage are causing problems at the wood trestles and the steel bents. The structural steel base plates and anchor bolts of the steel bents are partially covered with vegetation and, in several locations, are below existing grade and exposed to standing water. The existing vegetation should be removed and the site graded to allow for drainage away from the existing structure and to

Heavy Vegetation in and around steel
bents at South Approach

allow 6 to 12 inches of clearance between the final grade and the top of concrete piers.

Clear and grub the existing vegetation from the south approach of the bridge from the south abutment to approximately MacCorkle Avenue. Regrade the entire area so that the top of concrete at all foundations is at least 6 inches above the surrounding grade. Provide new drainage piping as required to accommodate revised site grading. Power wash all of the structural steel base plates and the top of existing concrete foundations.

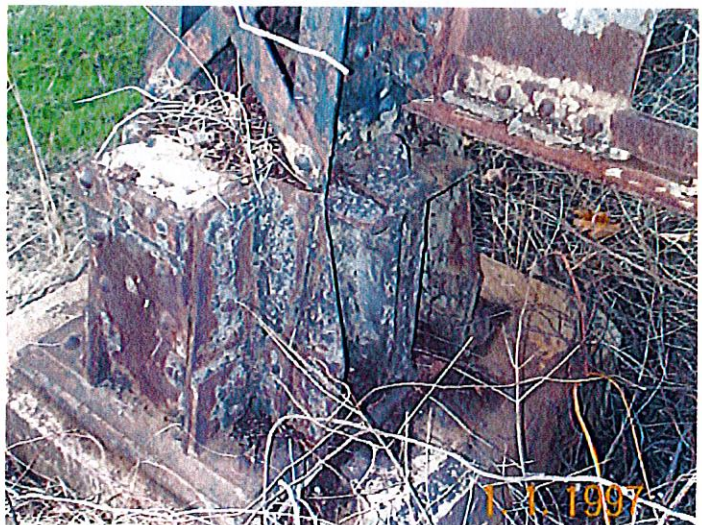
Deteriorated Base Platform
Connection at South End

Remove damaged and deteriorated steel sections at the base plates, the lower sections of the steel bents, and the bracing, and replace with steel of a similar size and section. Work is assumed to include abatement of lead based paint on the lower 10 feet of the steel bents.

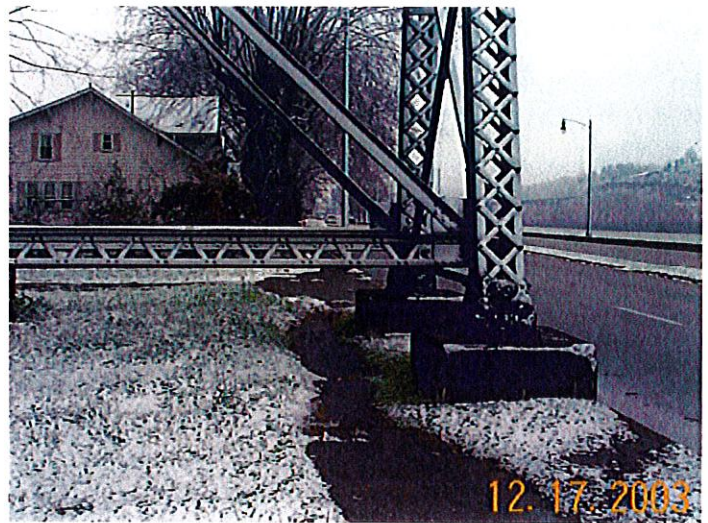
Bracing Blocking Kanawha Blvd.
Sidewalk. This brace can be raised or
relocated to provide adequate headroom
for pedestrians.

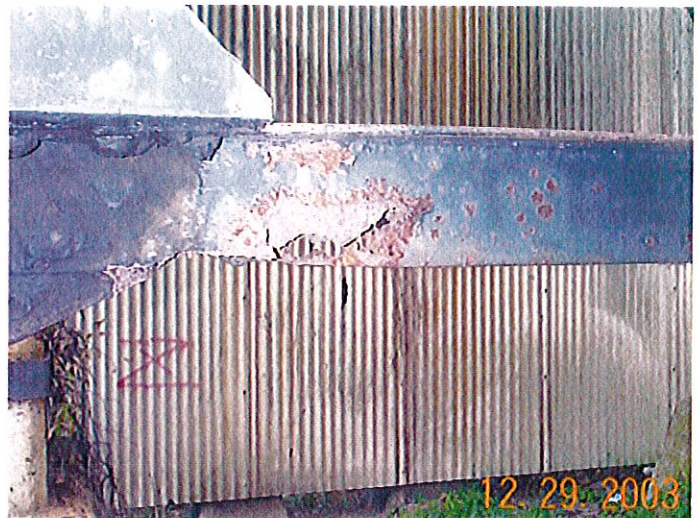
In the existing steel bents near Second Avenue, there were at least two anchor bolts that were observed to be completely rusted through, and in one case, missing. In the same steel bent, the bottom steel angles of the existing bent are almost completely rusted through. If both the anchor bolts and the bottom steel angles are ineffective, a structural stability problem may be created in the existing bent. Similar problems may be found in other bents, obscured now by soil, debris, and corrosion.

Deteriorated bottom steel tie at Second
Avenue Crossing. This steel member
will have to be replaced.

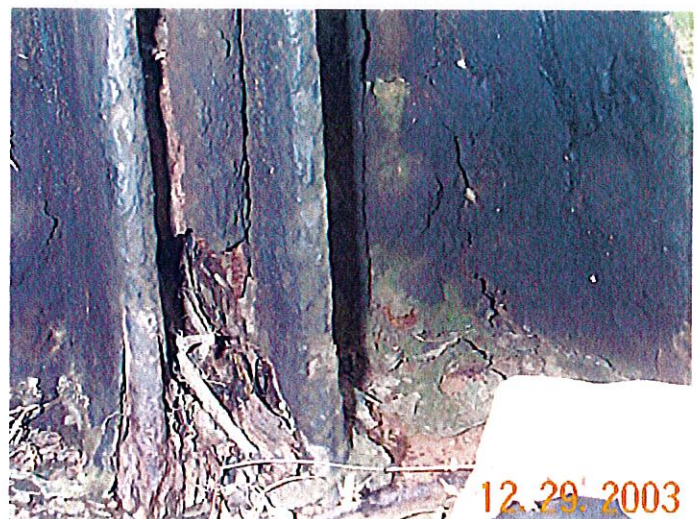
Deteriorated Anchor Bolt near Second
Avenue Crossing. Note that the lower
half of the bolt is gone.

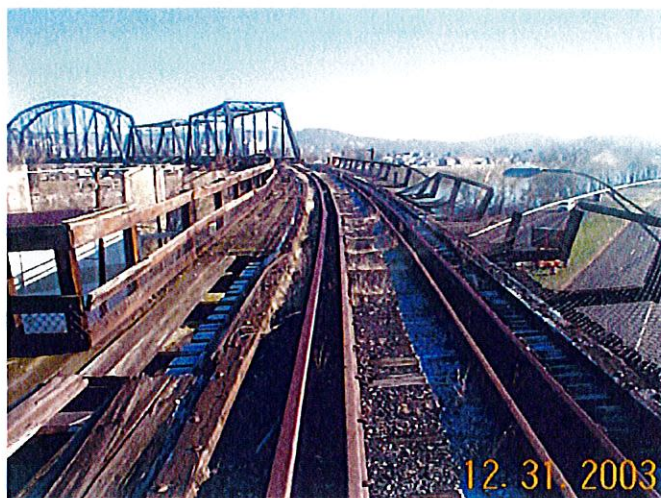
Many of the existing wood cross ties in the MacCorkle Avenue crossing may be in poor condition since they were installed without lateral clearances to prevent material from falling off the train and through the bridge. This has allowed dirt and gravel to accumulate on the ties and has allowed vegetation to grow on the tracks. Ties in this area should be cleaned off and thoroughly inspected for rot and damage due to vegetation.

Ties are closely spaced to prevent material from falling through to MacCorkle Avenue has allowed vegetation growth causing possible tie damage. Note missing boards at the walkway to left.

Remove and replace approximately 5 percent of the damaged and deteriorated treated wood crossties with treated wood crossties of a similar size. Some good existing wood crossties may be displaced by the handrail installation and available for replacement.

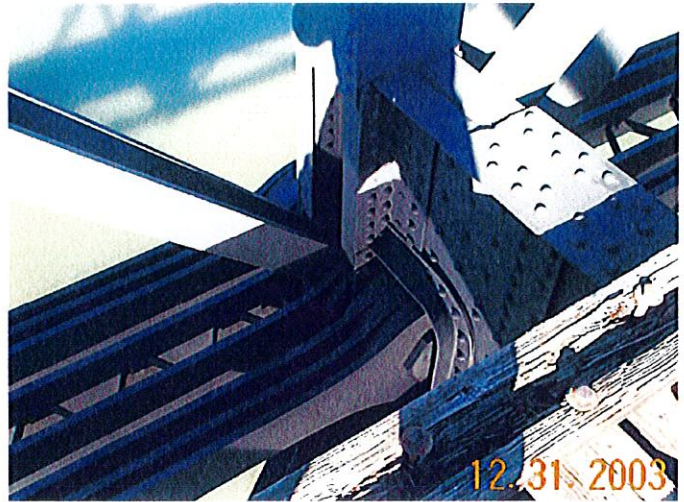
Bottom Chord of Main Truss showing
eight (8) Eye Bar Truss members.
Selected number of joints should be X-
rayed to verify member capacity

X-ray selected pin connected steel eyebars at the lower chord of all four steel truss spans to determine if there is any hidden corrosion or deterioration. Please note that this work should be done before the purchase of the bridge is finalized, due to the potential cost of eye bar repairs, if required.

X-ray selective eye bar joints at the lower chord panel points of all four trusses. **This work should be done prior to finalizing bridge purchase.**
